## PIC18F2515/2610/4515/4610 Rev. A3 Silicon Errata

The PIC18F2515/2610/4515/4610 Rev. A3 parts you have received conform functionally to the Device Data Sheet (DS39636D), except for the anomalies described below. Any Data Sheet Clarification issues related to the PIC18F2515/2610/4515/4610 will be reported in a separate Data Sheet errata. Please check the Microchip web site for any existing issues.

**The following silicon errata apply only to PIC18F2515/2610/4515/4610 devices with these Device/Revision IDs:**

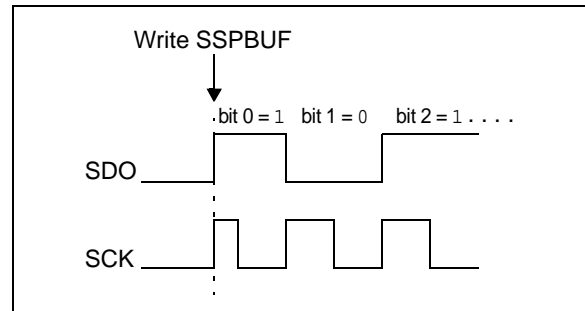
**FIGURE 1: SCK PULSE VARIATION USING TIMER2/2**

When the SPI is using Timer2/2 as the clock source, a shorter than expected SCK pulse may occur on the first bit of the transmitted/received data (Figure 1).

### Work around

To avoid producing the short pulse, turn off Timer2 and clear the TMR2 register, load the SSPBUF with the data to transmit and then turn Timer2 back on. Refer to Example 6 for sample code.
